UNITED STATES OF AMERICA
FEDERAL ENERGY REGULATORY COMMISSION

Ramm Power Group LLC

Project No. 14869-000

NOTICE OF INTENT TO FILE APPLICATION FOR
Original FERC LICENSE

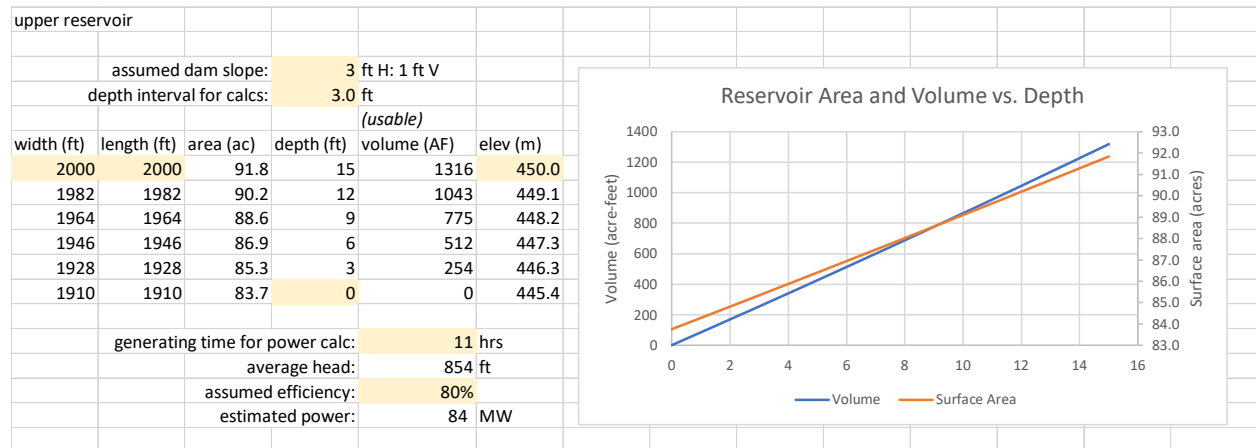
UPPER RESERVOIR & DAM

Optimization of the upper reservoir and dam are under way. The data and chart above describe the differing scenarios under consideration. Further engineering must be accomplished in order to finalize the project.

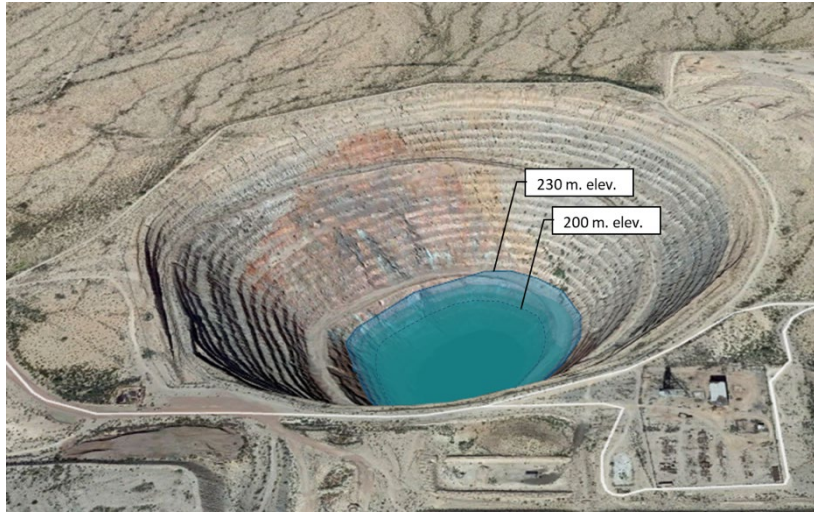
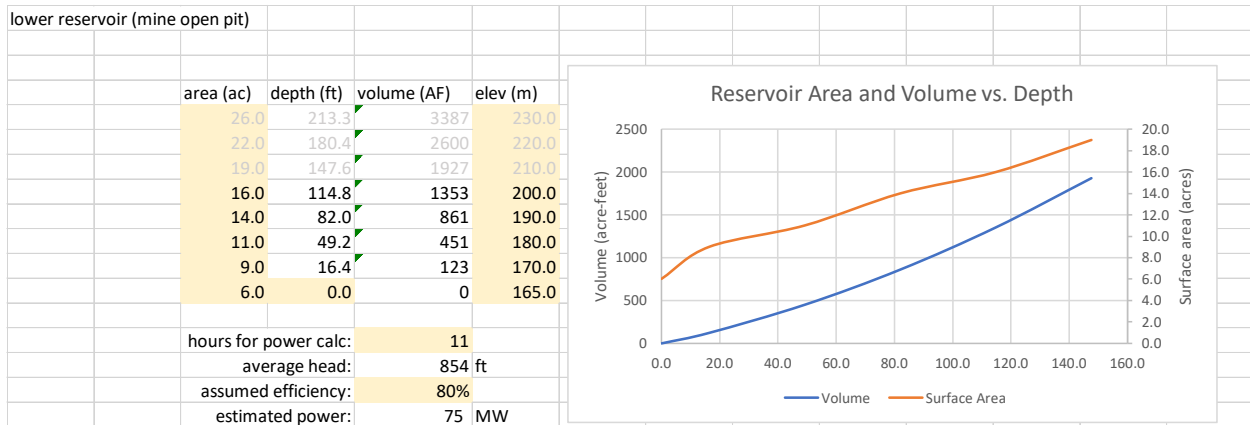
LOWER RESERVIOR

Optimization of the lower reservoir is under way. The data and chart above describe the differing scenarios under consideration. Further engineering must be accomplished in order to finalize the project.

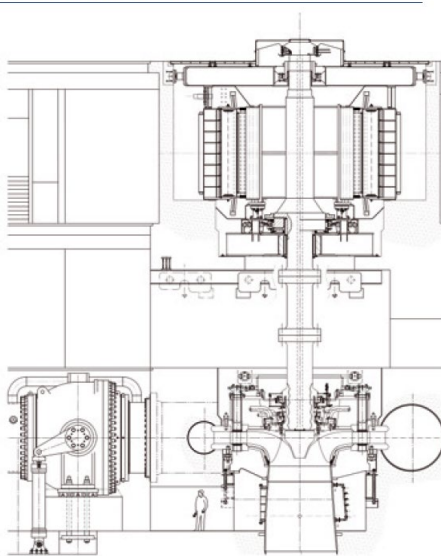
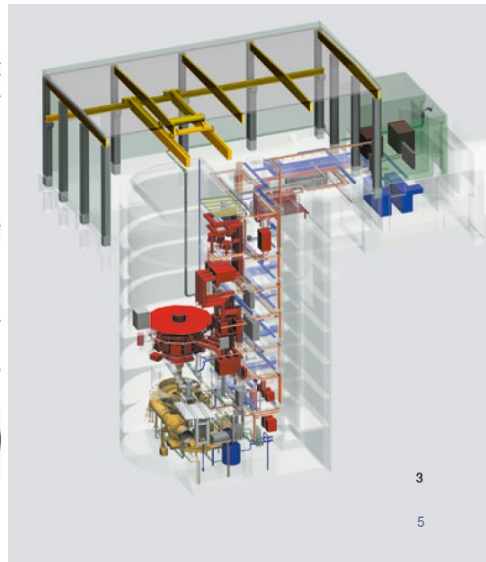
Cross section of a Pump turbine/ Generator unit

Two 80-MW Ternary Style Turbines, manufactured by Voith Hydro Power. Please see below our Conceptual Single Line Diagram, cross section of a ternary machine and conceptual installation scheme for two of the Ternary Units.

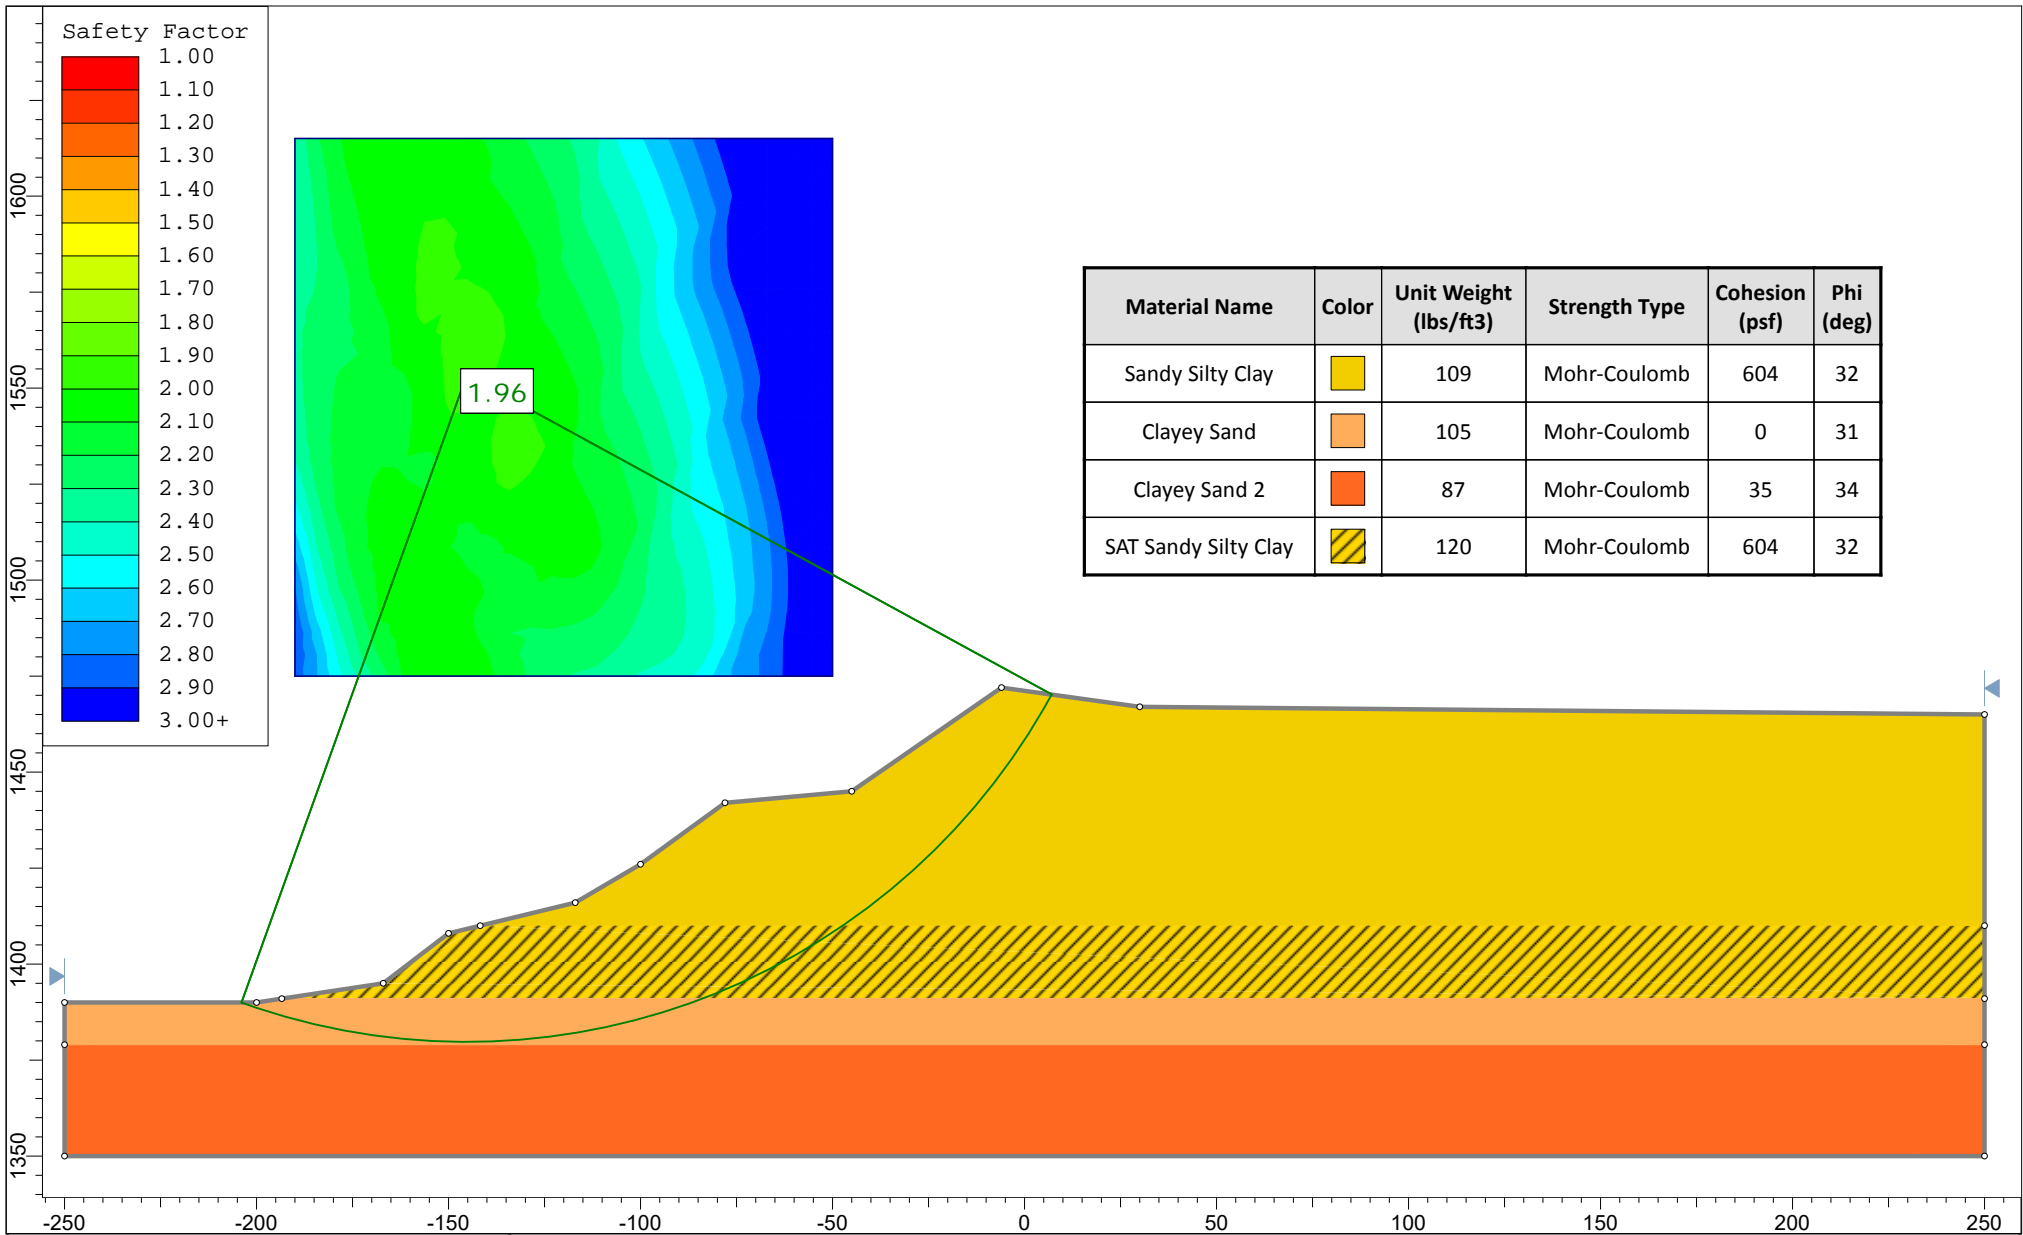
Project			Sacaton Mine - # 117-321059-2018 - Slide Model		
	Analysis Description			TSF Existing Slope - Sta. 69+00, Section 8		
	Drawn By	JD	Scale	1:600	Company	Tetra Tech
	Date	7/27/2018		File Name	Existing Slope Sect 8 Sta 69+00.slim

Strength testing was conducted on tailing and alluvium material for stability analyses and it was determined that existing side slopes on the TSF are geotechnically stable under static and pseudo-static conditions.

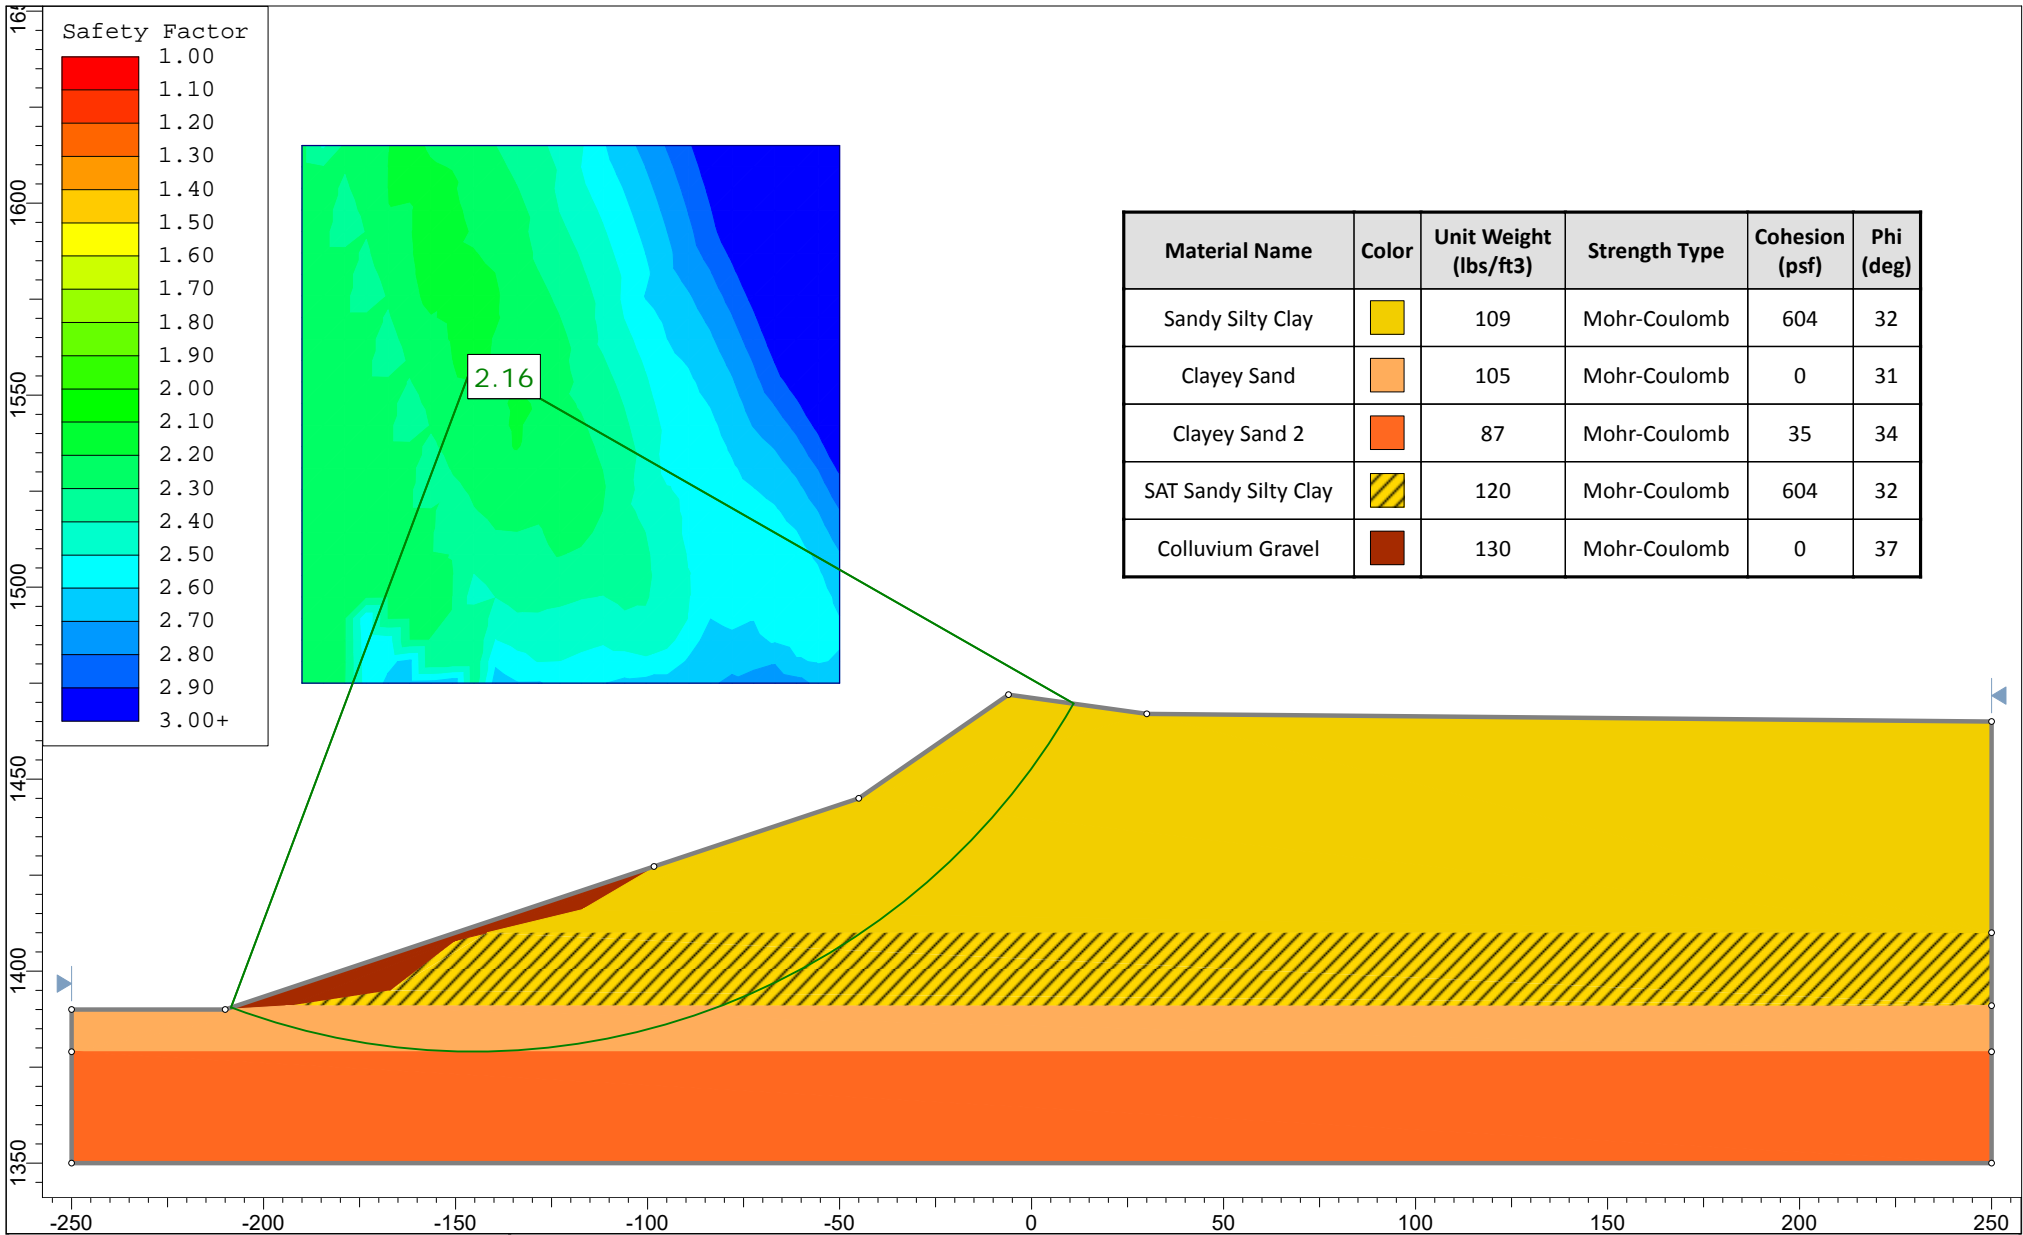
Project				Sacaton Mine - # 117-321059-2018 - Slide Model	
Analysis Description				TSF Proposed Slope - Sta. 69+00, Section 8	
Drawn By	JD	Scale	1:600	Company	Tetra Tech
Date	7/27/2018			File Name	Prop Slope Sect 8 Sta 69+00.slim

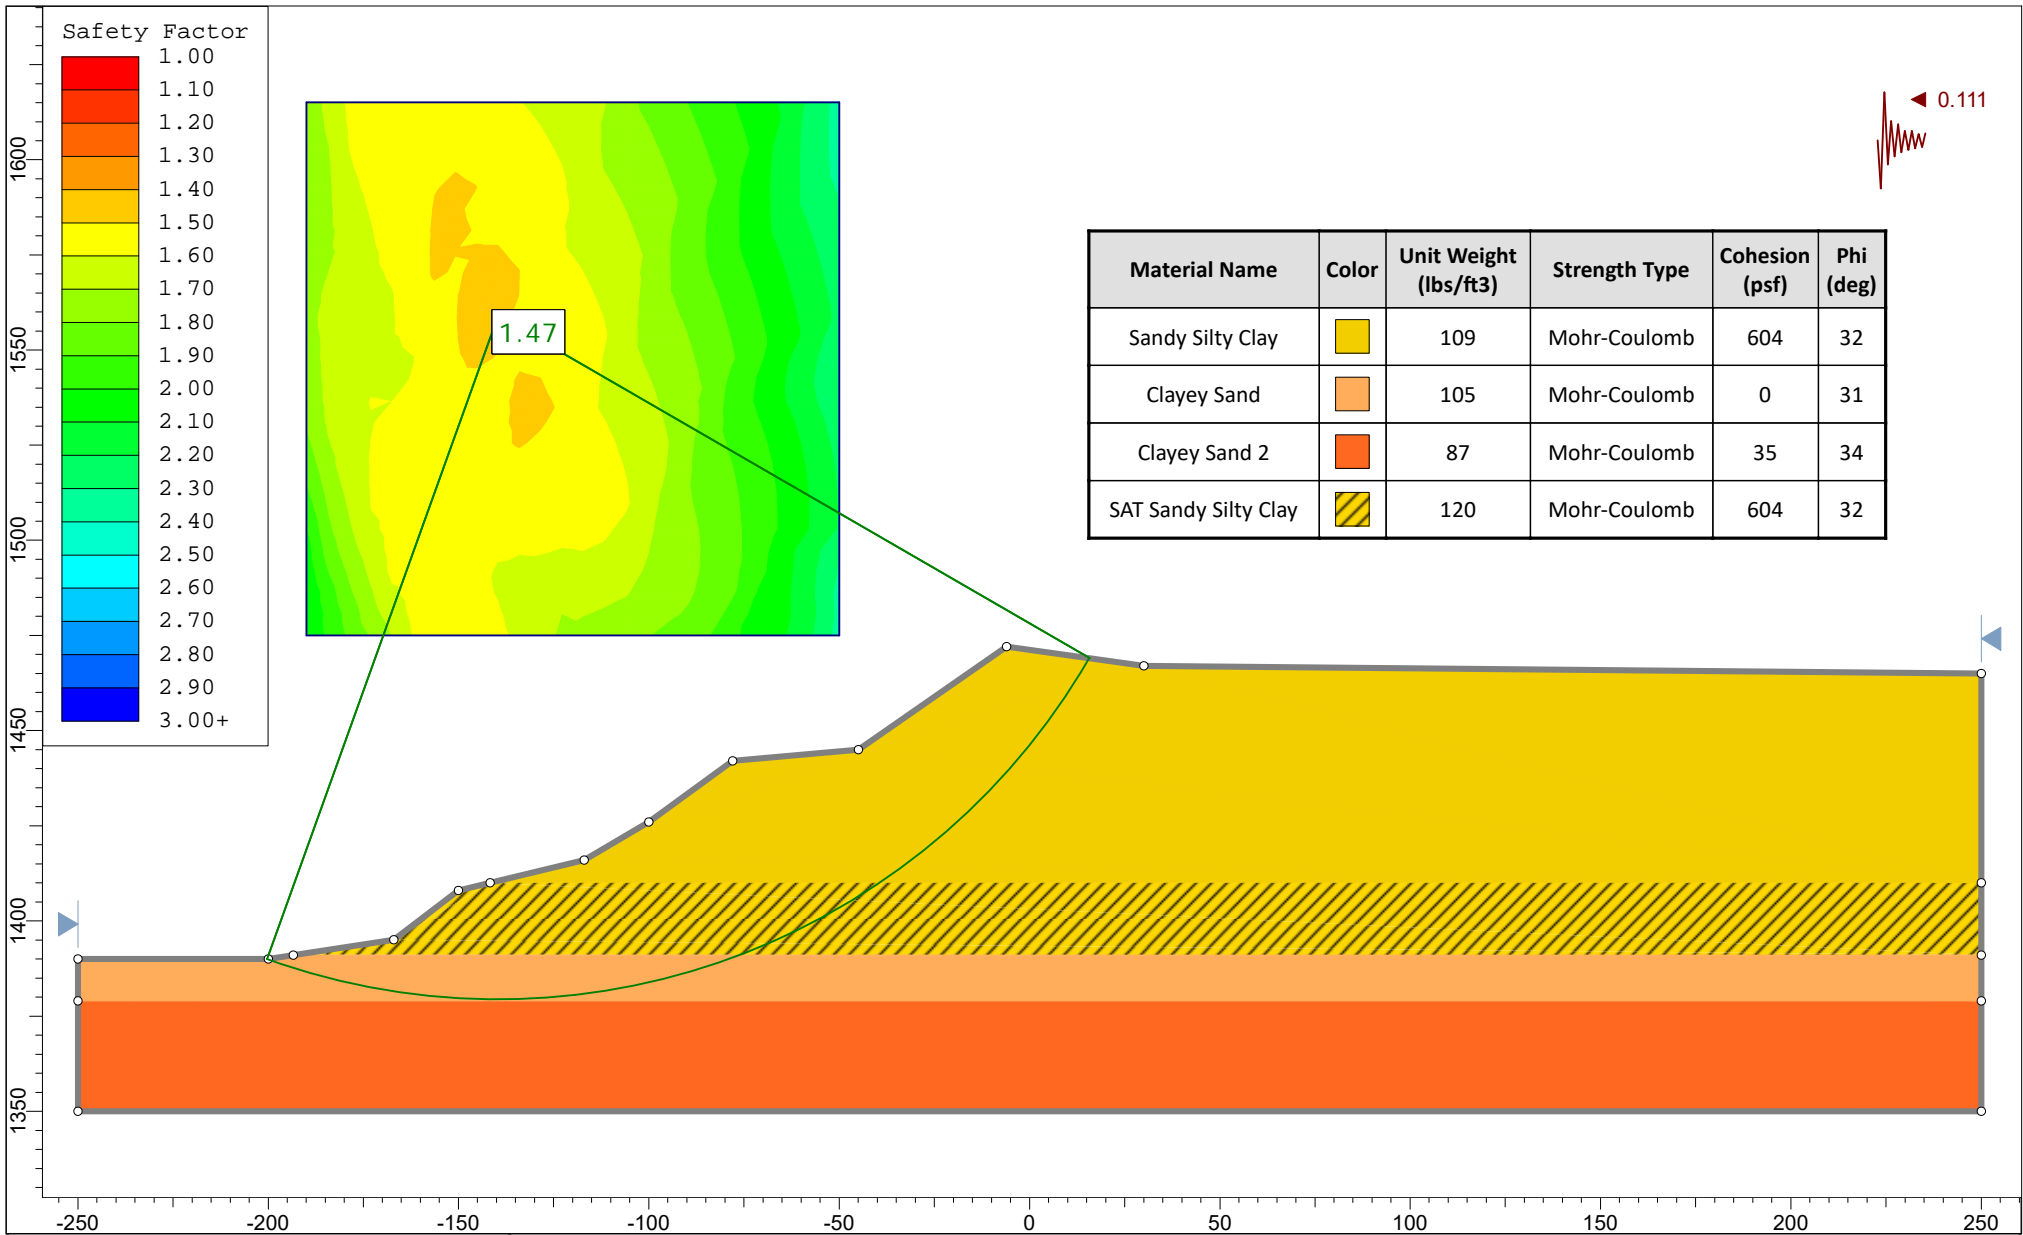
Project		Sacaton Mine - # 117-321059-2018 - Slide Model		Figure - 1D	
	Analysis Description		TSF Existing Slope - Sta. 69+00, Section 8			
	Drawn By	JD	Scale	1:605	Company	Tetra Tech
	Date	7/27/2018	File Name	Existing Slope Sect 8 Sta 69+00.slim

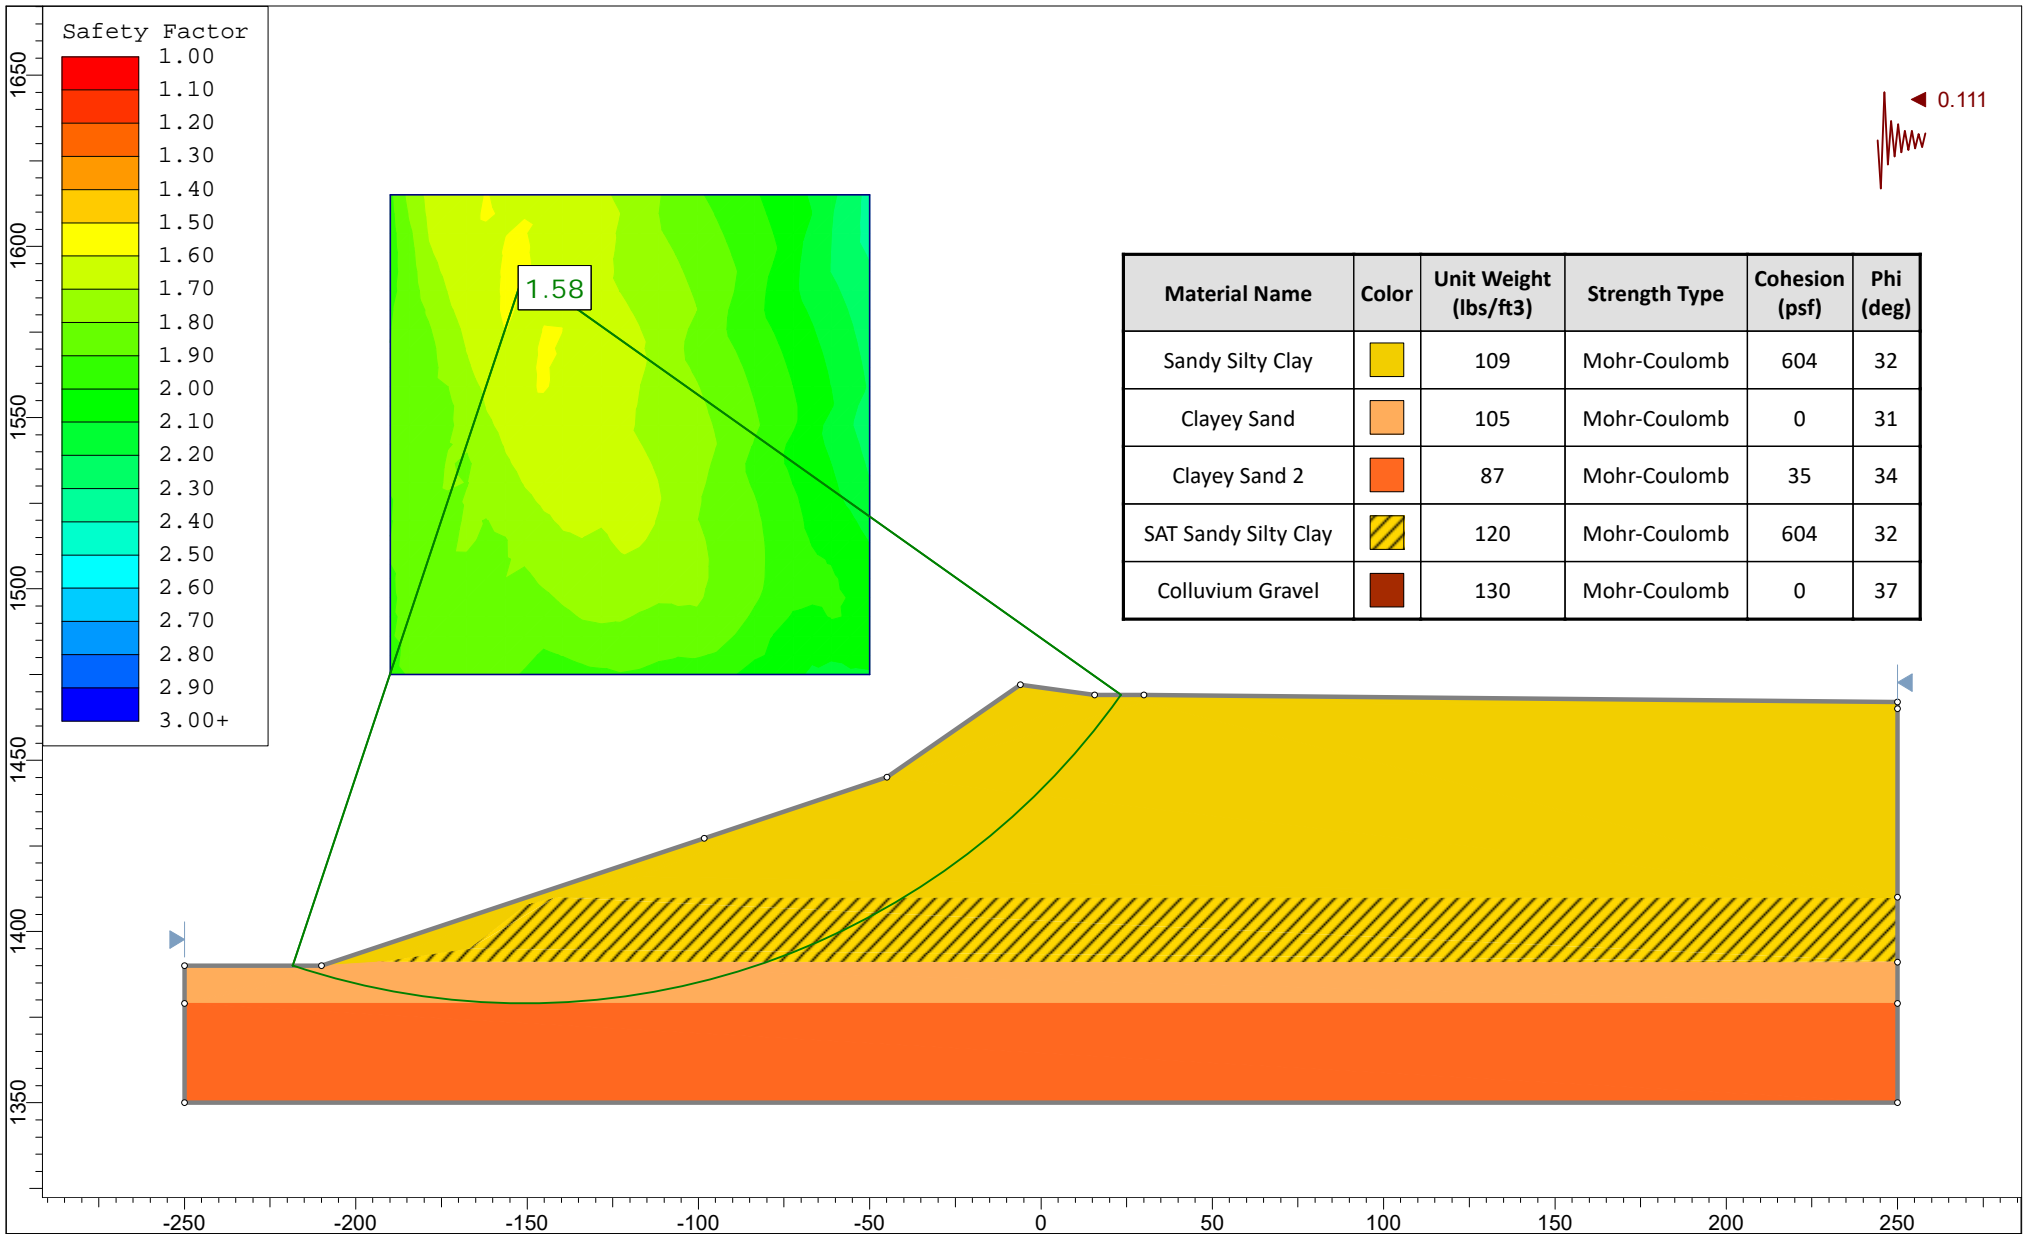
Project		Sacaton Mine - # 117-321059-2018 - Slide Model		Figure - 2D	
	Analysis Description		TSF Proposed Slope - Sta. 69+00, Section 8			
	Drawn By	JD	Scale	1:673	Company	Tetra Tech
	Date	7/27/2018	File Name	Prop Slope Sect 8 Sta 69+00.slim

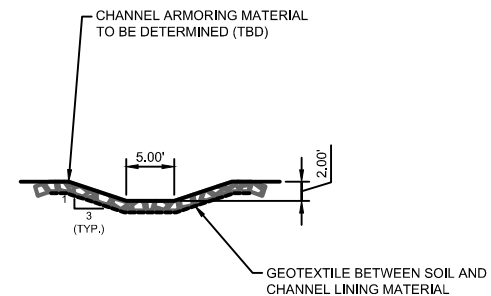
C SOUTHEAST POND OUTLET TYPICAL SECTION
C-103 NTS

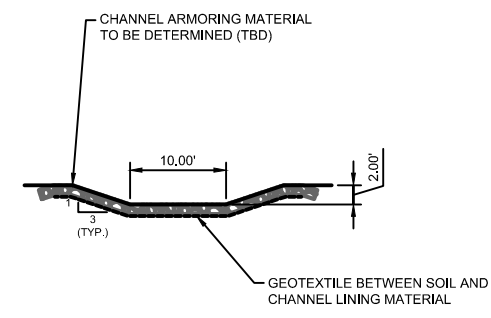
E SOUTHWEST POND OUTLET TYPICAL SECTION
C-104 NTS

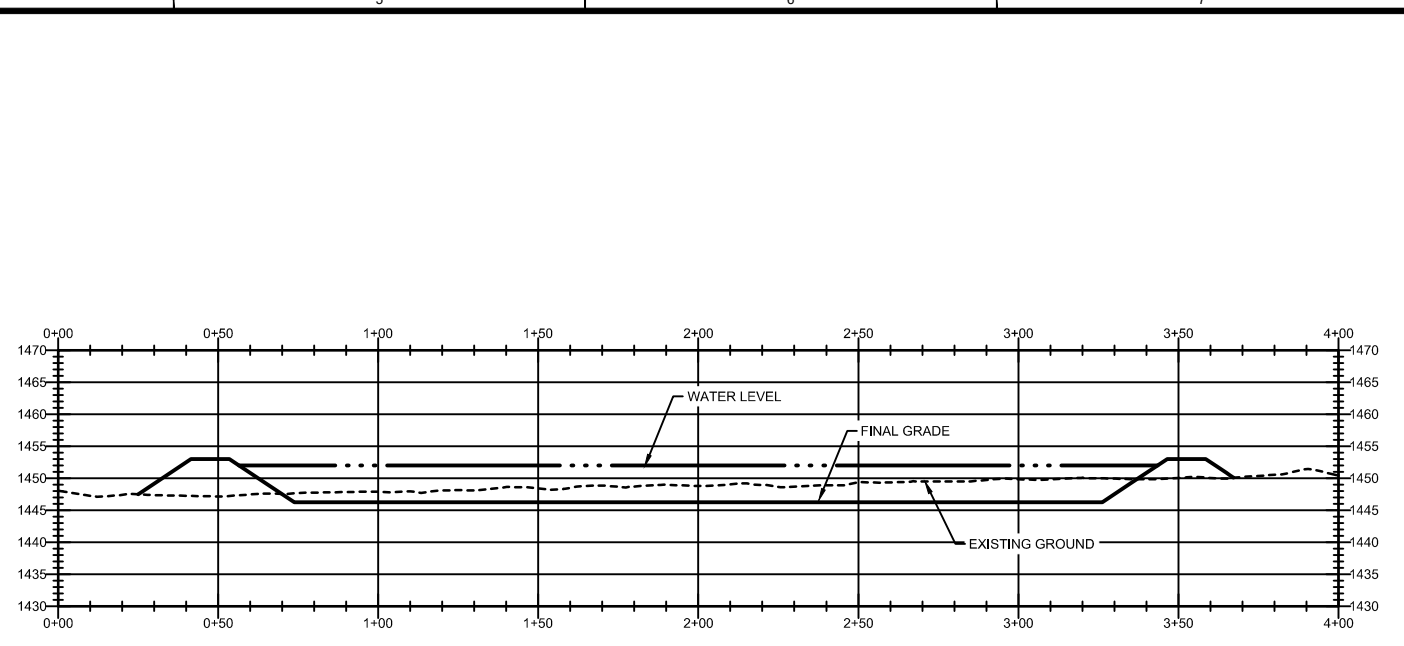
I WATER STORAGE POND SECTION
SCALE: 1" = 60' H / 1" = 30' V

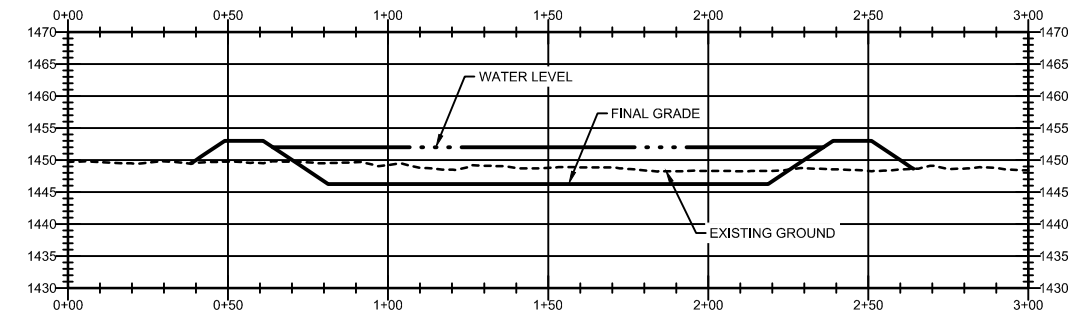
J WATER STORAGE POND SECTION
SCALE: 1" = 60' H / 1" = 30' V

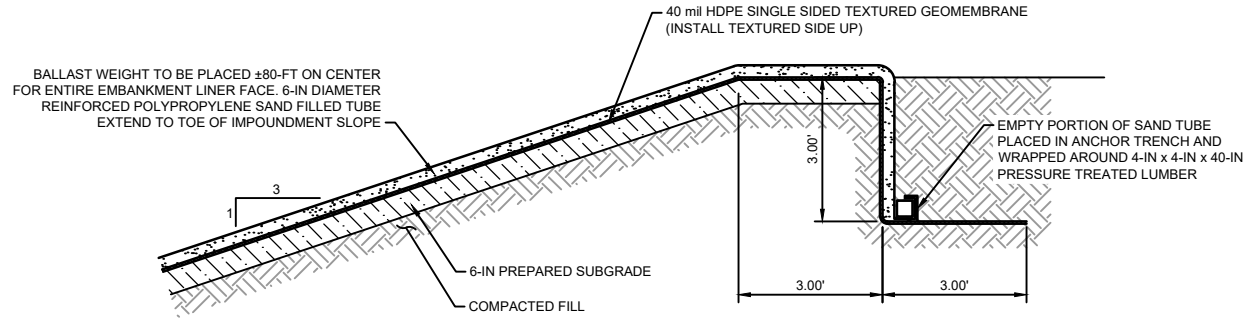
1 TYPICAL ANCHOR TRENCH AND BALLAST DETAIL
C-108 NOT TO SCALE

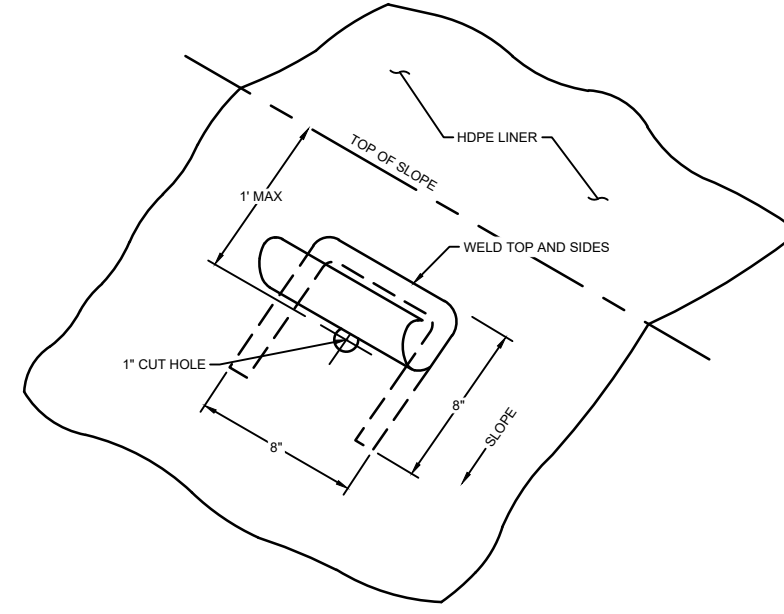
2 PRIMARY GEOMEMBRANE FLAP VENT
C-108 NOT TO SCALE
